AIRCRAFT ACCIDENT REPORT

ASSOC/2013/10/03/F

Accident Investigation Bureau

Report on the Accident involving Associated Airlines Limited Embraer 120 ER aircraft with registration 5N-BJY, which occurred at Murtala Muhammed Airport, Lagos on 3rd October, 2013.

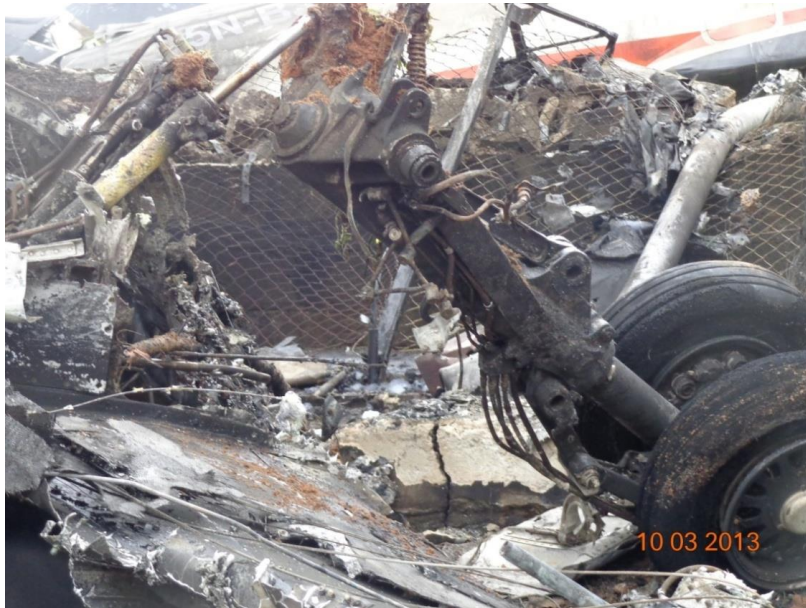
Figure 1: The Damaged Landing Gear in the extended position

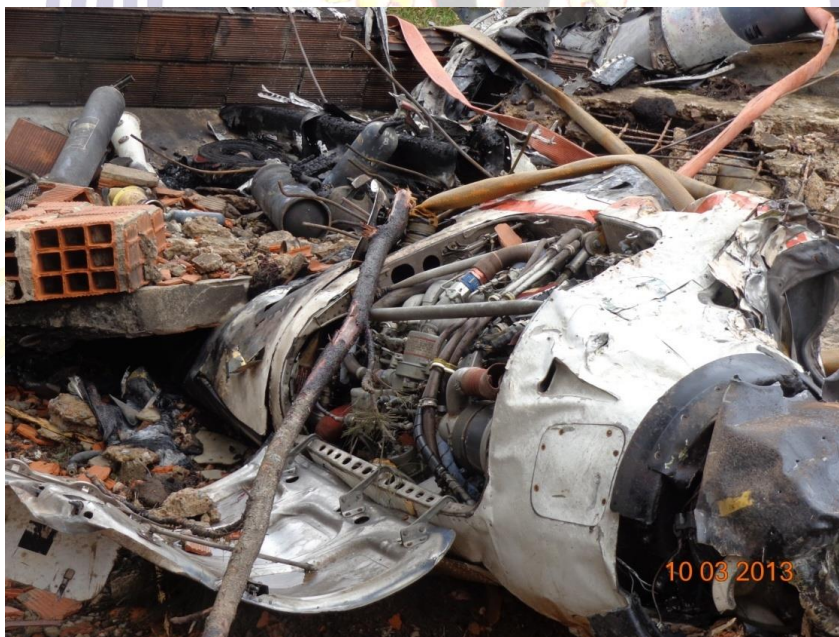
Figure 2: Part of the Aircraft and the damaged wall fence

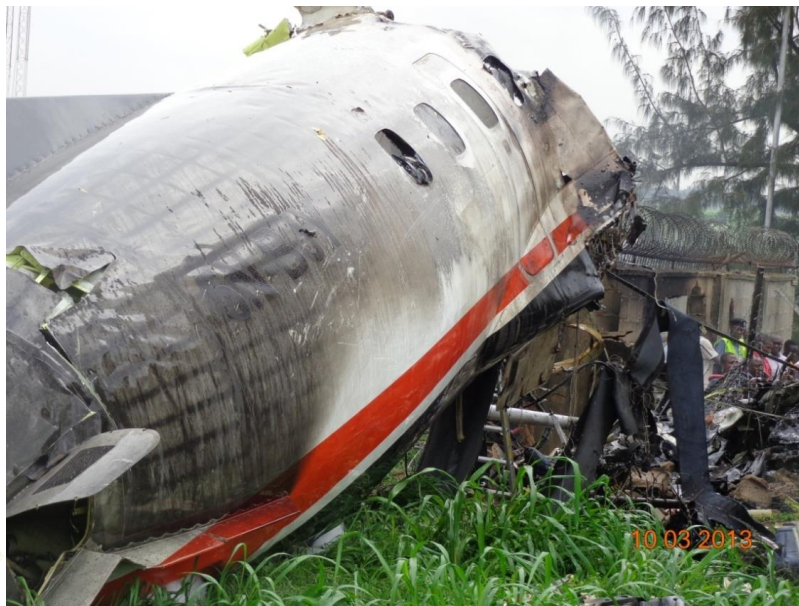
Figure 3: Aircraft rear section showing burnt areas

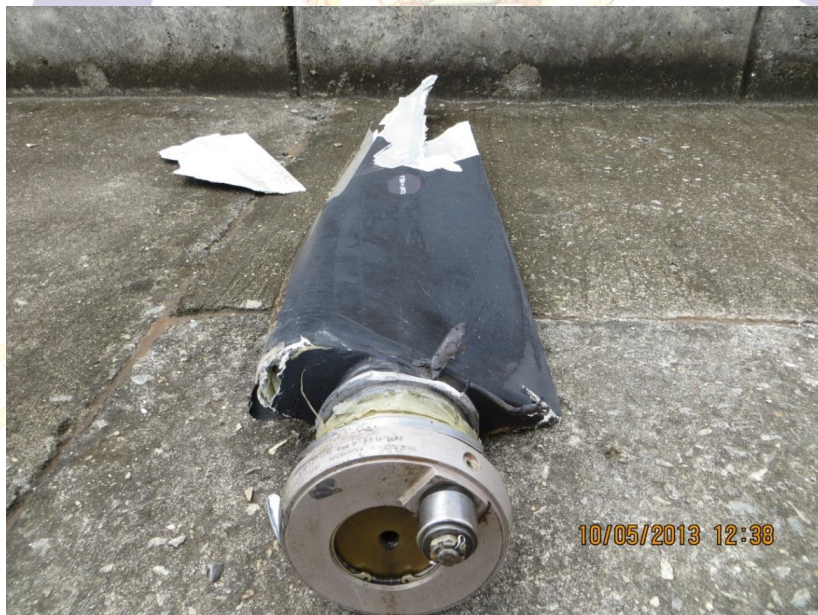
Figure 6: Damaged Propeller Blade at the Crash Scene

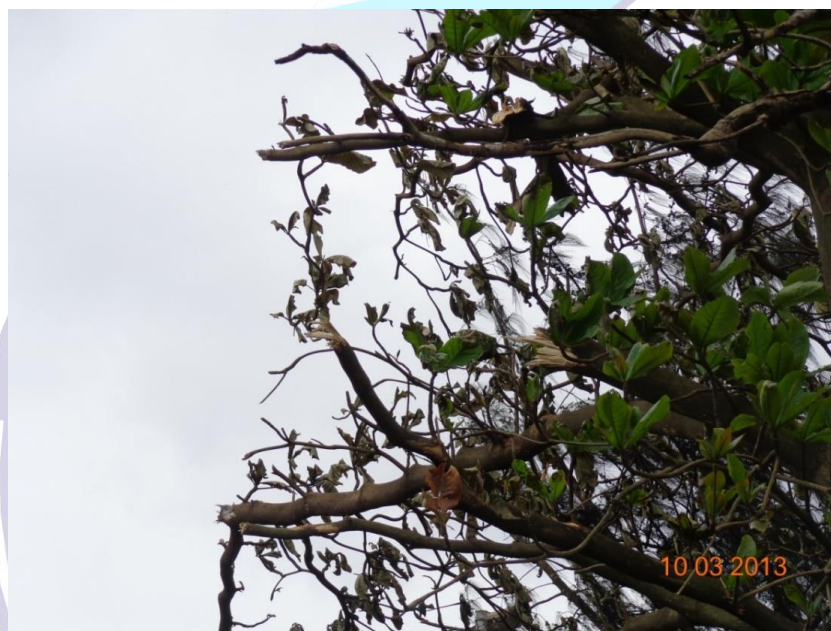
Figure 7: A Tree impacted by the Aircraft

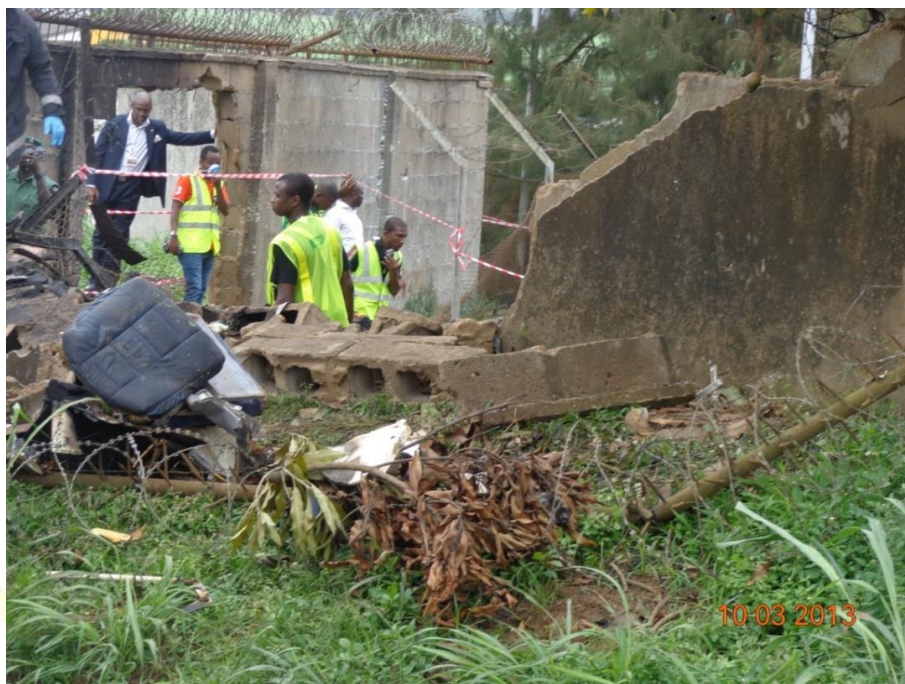
Figure 10: A seat destroyed and flung out of the Aircraft and the damaged JUHI fence

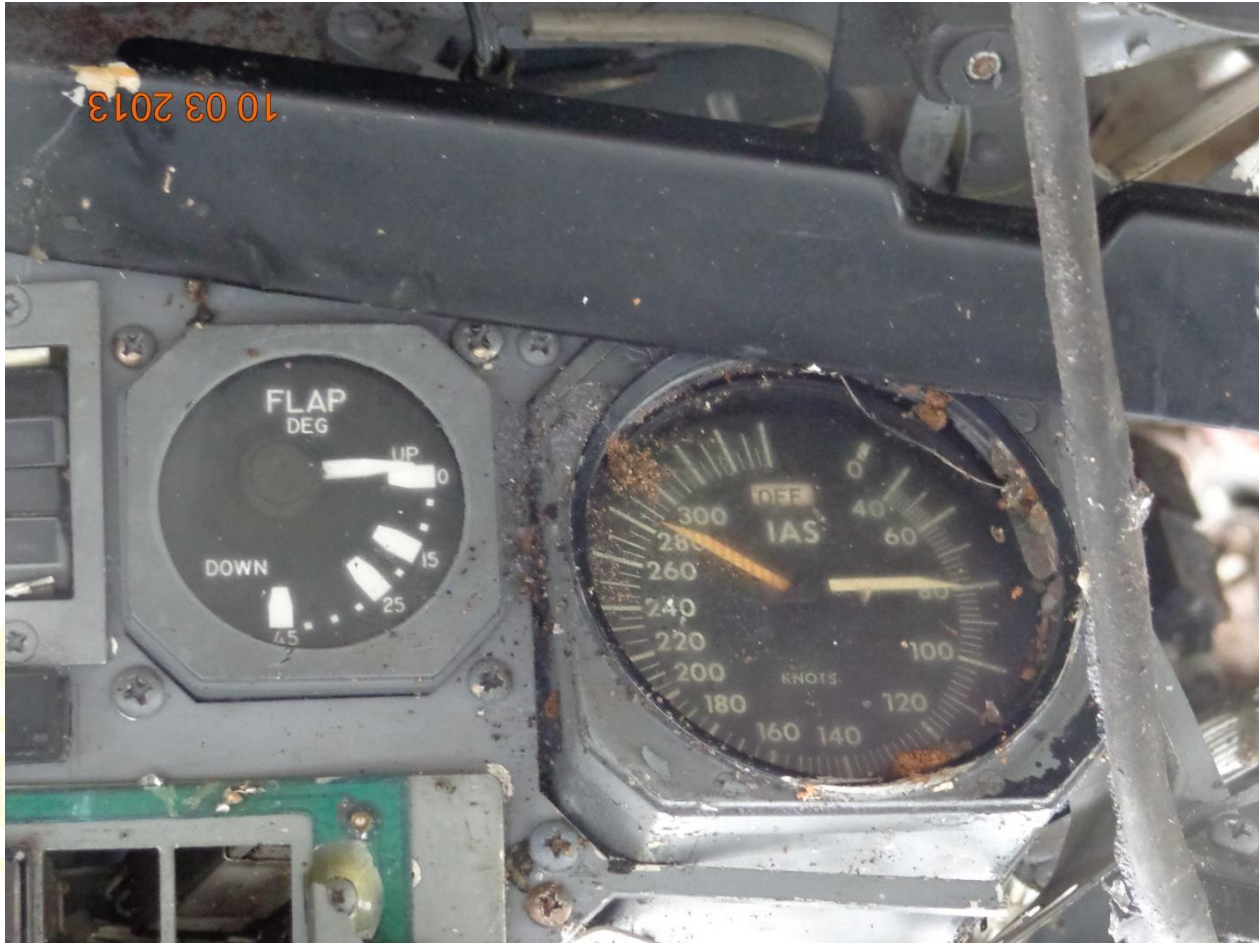
During wreckage examination the airspeed indicator was reading about 80kts and the flap handle was found to be at the 15° detent.

Figure 19: Flap Gauge Indicating 0°

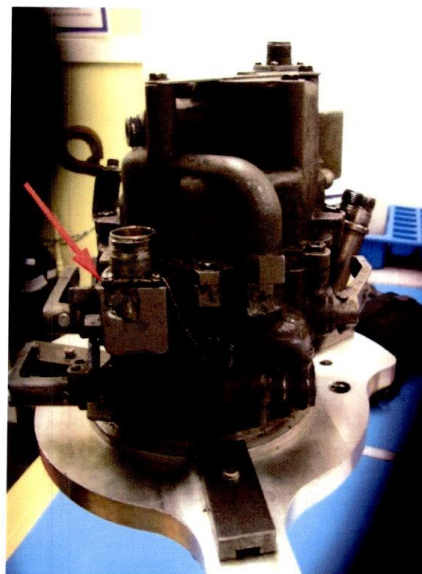
Figure 2. PCU Housing damage.

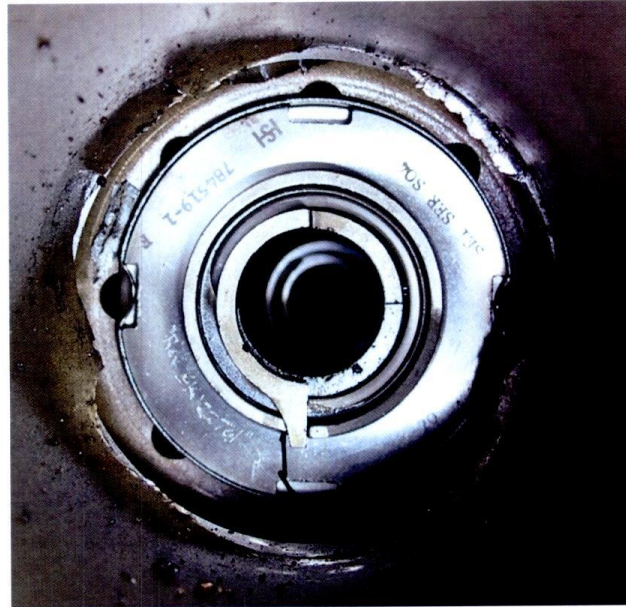
Figure 13. Broken Actuator Yoke Tailshaft.

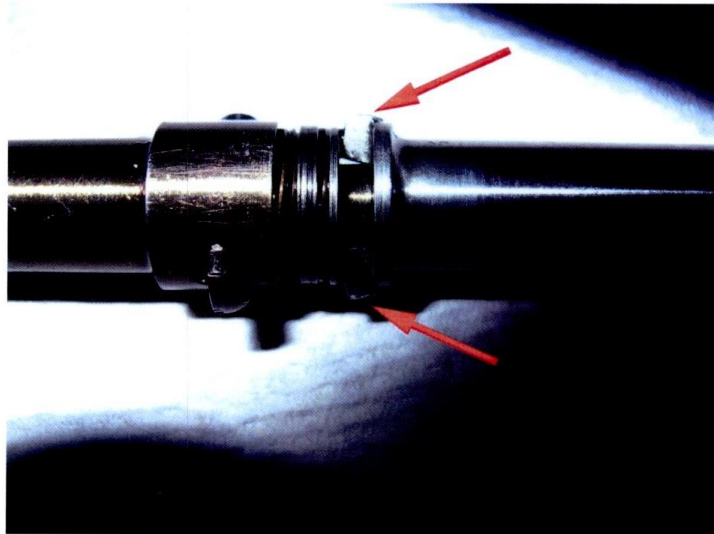
Figure 16. Broken Transfer Tube Retainer Tabs.

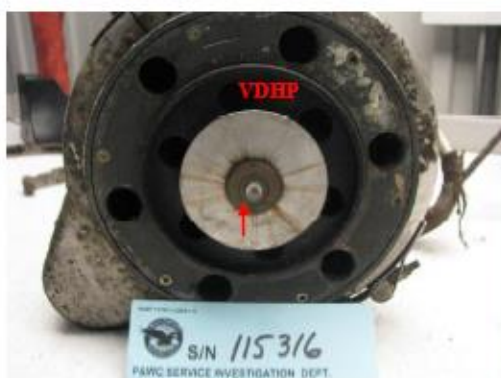
Photo no. 26

- 4.2 On removal, the VDHP and ACG drive shafts were found shear-fractured by overload at their shear neck (photo no's 26 to 29, arrows). The AFP showed impact damages with deformation and partial opening of the unit (photo no. 30). The oil strainer of the AFP was clean (photo no. 31). The other airframe accessories components showed impact gouging damages. On behalf of the AIB Nigeria Authorities request, P&WC shipped the PCU, AFP, VDHP, ACG and the Propeller Hub with the beta tube (rod) to the respective accessories controls suppliers.

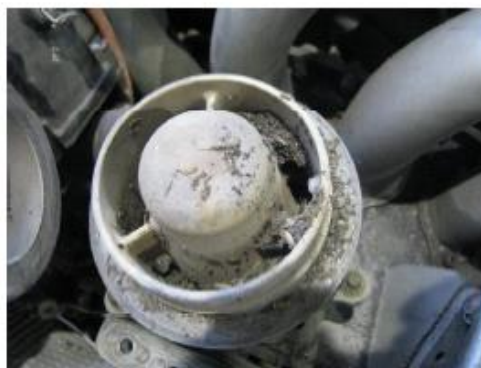
Photo no. 32

- 4.3 The external of the entire engine including the externals was covered with ground sooty dirt and organic contaminants such as grasses, straws, wood chips, peddles and pieces of red brick-tiles. The P2.5 pneumatic valve of the cabin air supply (ECS, photo no. 25) installed on the inter-stage compressor case (ICC) was contaminated and clogged with a mixture of ground dirt and organic debris (photo no. 32).

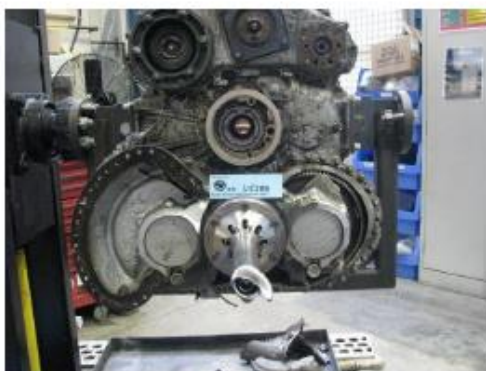
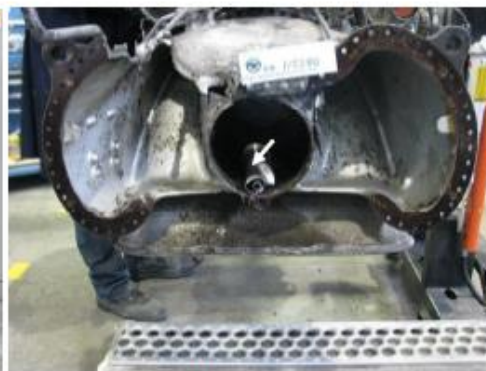
Views of the fractured RGB input housing and FIC at the mating flange.

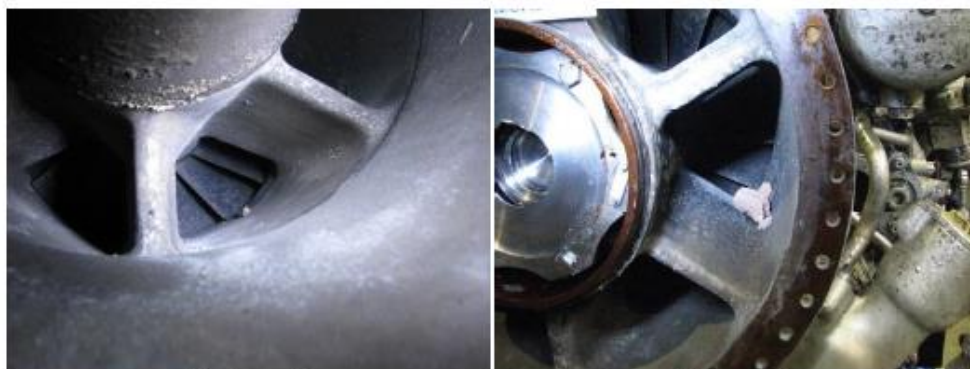
Photo no. 61

- 5.4 The inlet wall (cold section gas-path) of the FIC and rear inlet case (RIC) was contaminated and covered with dirt, red-brick tile and organic debris (photo no's 61 & 62). Corrosion was also noted to the casing inlet walls (photo no. 61).

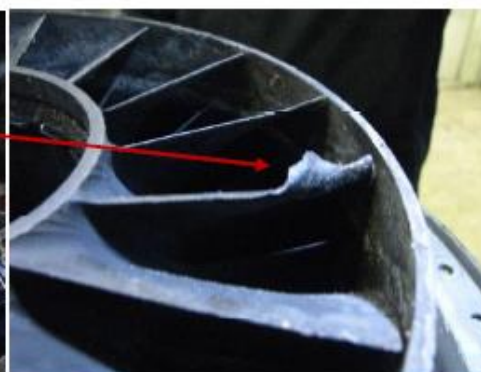
Photo no. 70 (Damaged vane L/E)

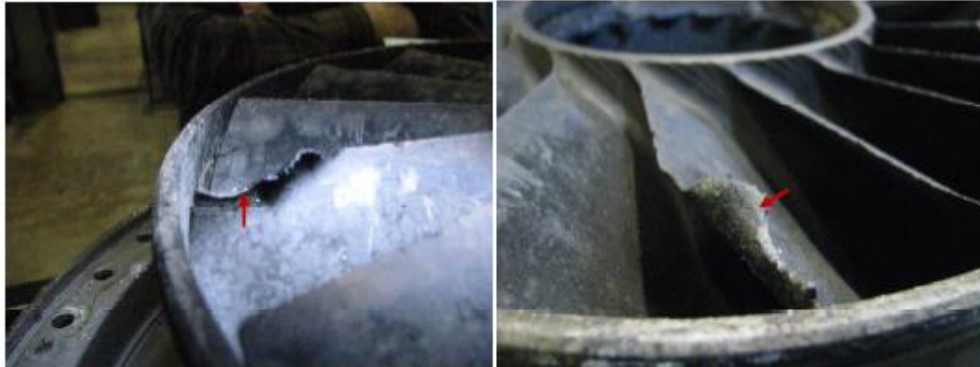
Photo no. 71 (Damaged vane L/E)

Alternate views of the impact-damaged vane L/E.

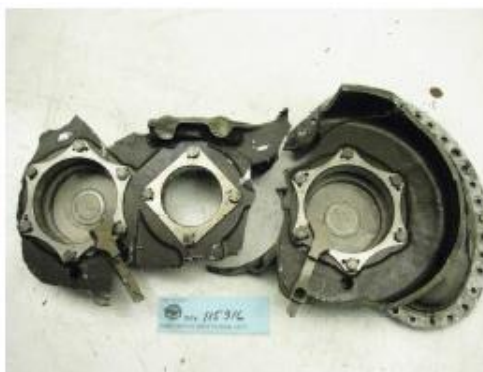
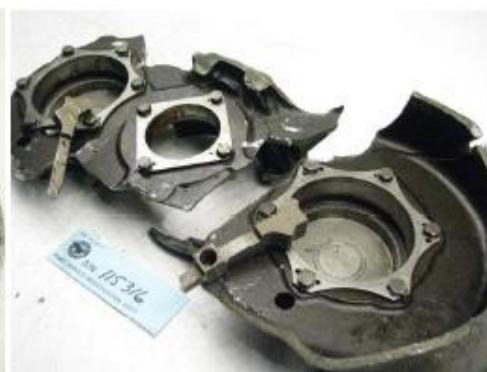
Alternate views of the fractured 1st stage reduction input-drive housing and oil transfer tubes, and rusted bearing outer races.

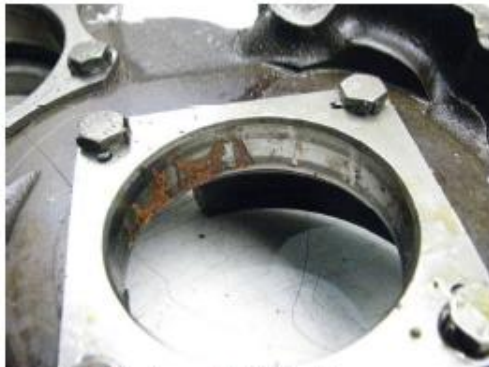
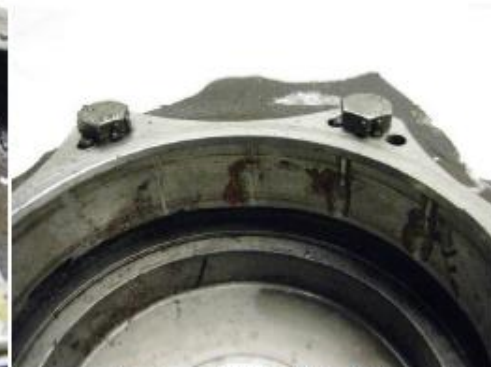
Close-up views of the rusted condition of two of 1st stage bearing outer races.

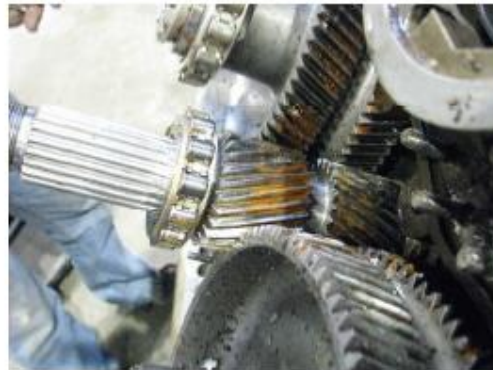
Photo no. 116

Close-up view of the rusted input drive gear with mating helical gears.

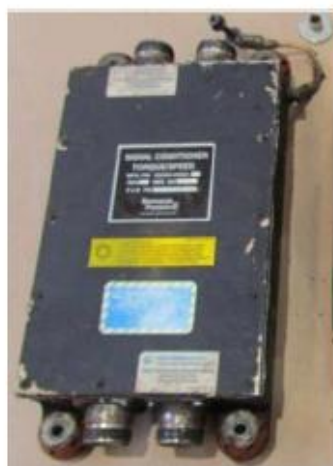
Photo no. 134

Visual inspection of the TSC in a dirty condition showed the lower RH mounting flange was bent. The Torque (TQ) trim plugs were missing. The electrical connectors (J6, J7, J10 & J11) were dirty but the connector contact pins were intact. The connectors were cleaned before the unit being bench-tested. The unit functional testing in accordance with calibration test-requirements showed all of the test points were successfully completed. The back cover was removed and the inspection of the electronic board displayed minor corrosion build-up on the filter support (arrow). Refer to photo no's 134 & 135.

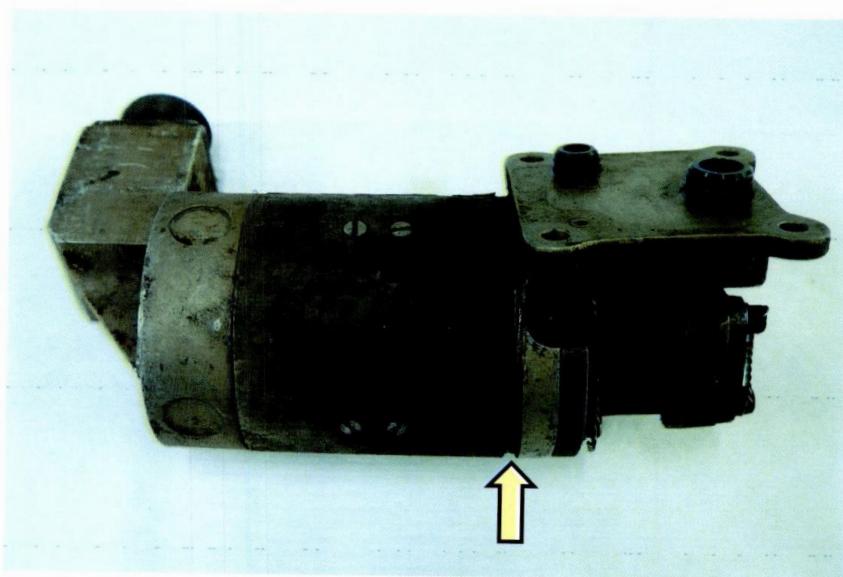
- 2.1.1 Exterior examination of the unit showed that the electric motor housing had separated rendering the unit inoperable. See red arrows in Figures 2 through 4. The damage appears to have occurred when the aircraft impacted the ground. The pump subassembly itself appeared to be intact. The mounting flange, hydraulic transfer tubes and electrical connector were all in good condition. All fasteners and lock-wire were present and did not appear to have been disturbed. See Figures 2 through 5.

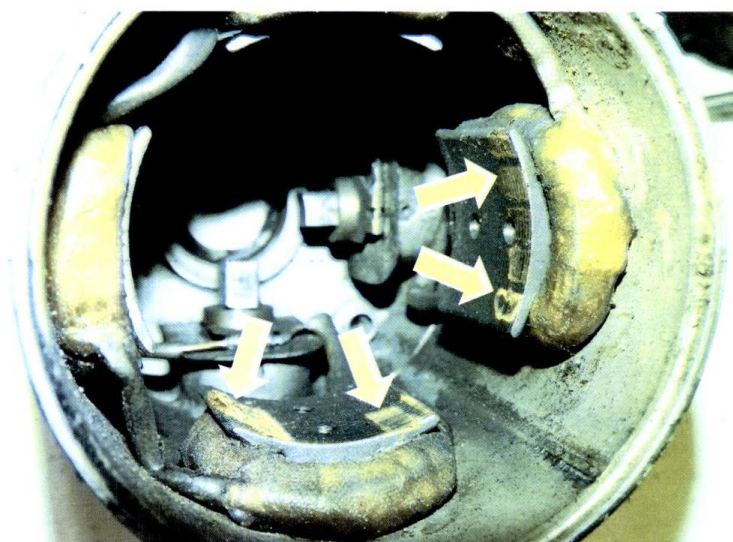
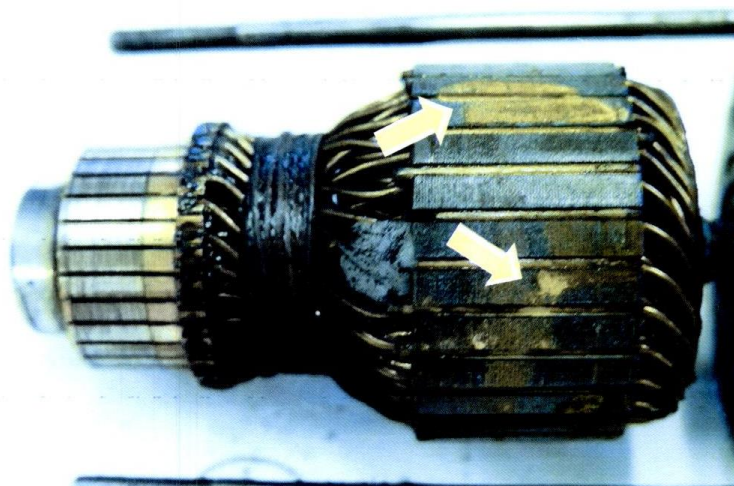
2.4.1.3 Lastly there was some light surface corrosion seen on two of the field magnets and matching marks on the rotor. See red arrows in figures 16 and 19. These most likely occurred after the accident when the aircraft was hosed down with water to extinguish the fire. Since the motor housing was bent and the rotor was now touching the stator. Water wicked between them where they were touching. That is most likely why the surface corrosion occurred. It should also be noted that light corrosion like this would not prevent the motor from working.

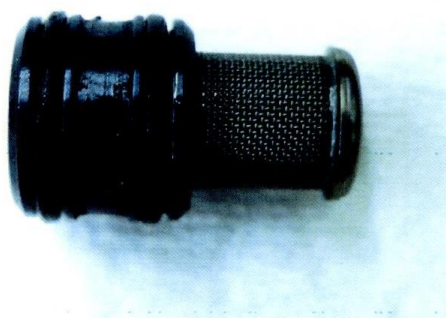
Figure 22
Pump Inlet Screen

2.4.2.2 Figure 22 shows the pump inlet screen which was removed for testing. It was clean and undamaged.

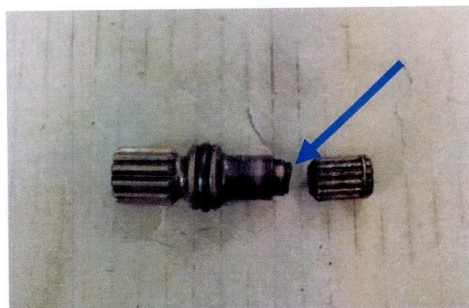
Photo 2 – Coupling Shaft Sheared

The coupling shaft was sheared when received. A metallurgical evaluation indicates the shaft failed due to torsional overload. There appears to have been very limited run time following the failure.

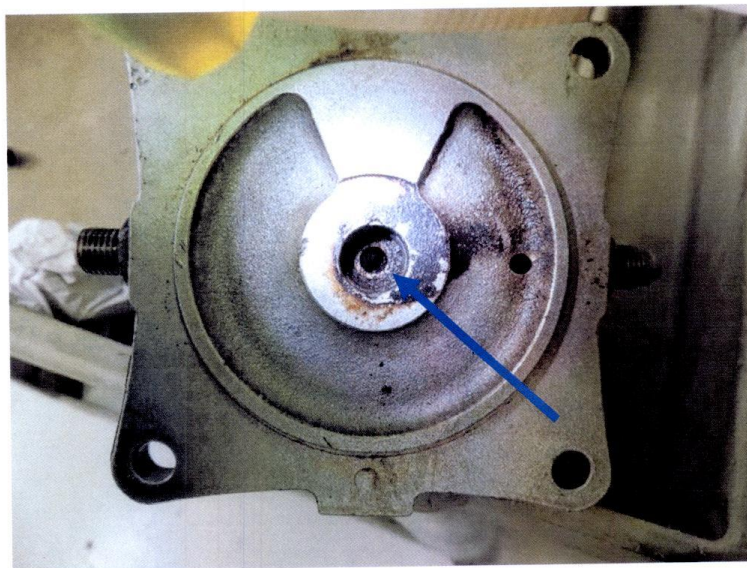
Photo 3 – Coupling Shaft

The coupling shaft failed in a torsional load. There appears to be some residual grease from the coupling shaft installation.
